# TECHNICAL PROPERTY REVIEW

123 Sample Street, Woodbridge, WA

SOURCE DOCUMENT

PremiumSampleReport-  
60Years-Old-House.pdf

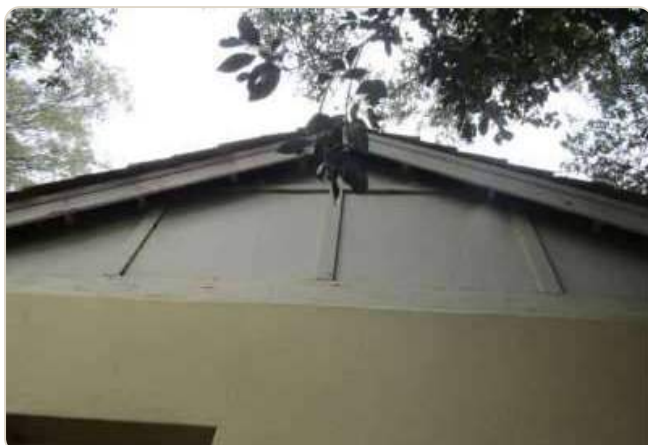
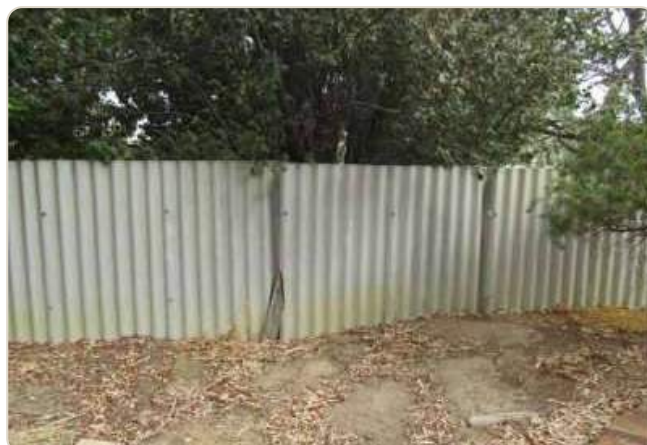
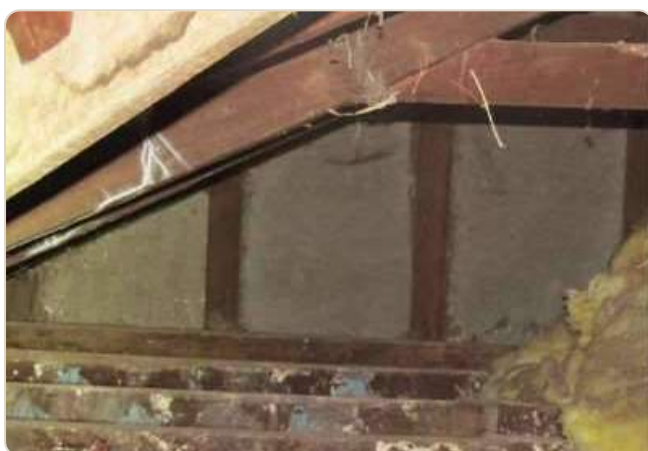
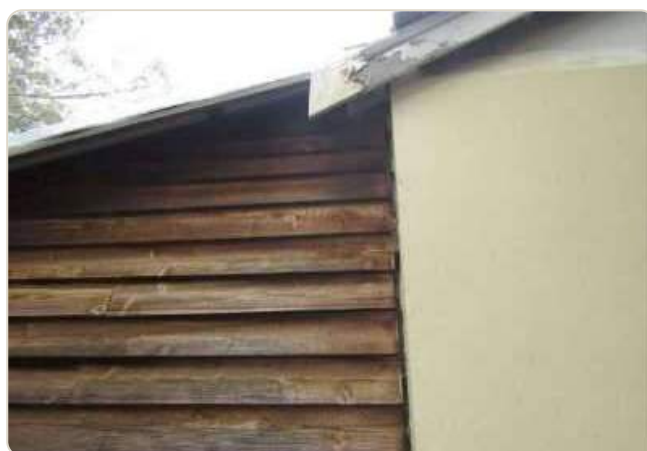
**THROUGHOUT PROPERTY — STRUCTURAL**

From our visual examination of the property, there is evidence of recent or ongoing foundation movement or subsidence cracking within the load-bearing walls and foundations that would be indicative of this type of recent ongoing movement. The existing limestone or bricked foundation should be investigated and possible underpinning of some load-bearing walls required to ensure no further movement takes place. This can be undertaken by either providing a concrete pad or microfine chemical grout injections under the footings.

The property shows signs of active foundation movement and cracking in the load-bearing walls. If not addressed, this can lead to further structural damage, affecting the stability and integrity of the home.

Engage a structural engineer to investigate the foundation movement and provide recommendations for underpinning.

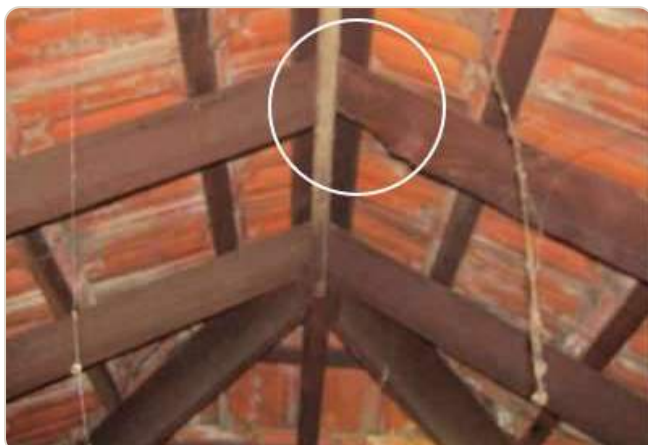
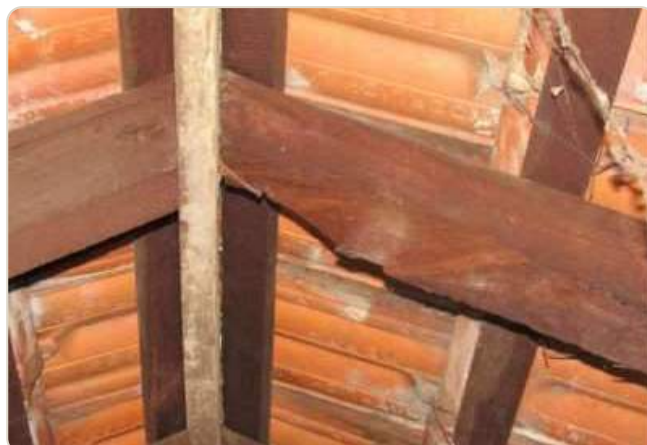
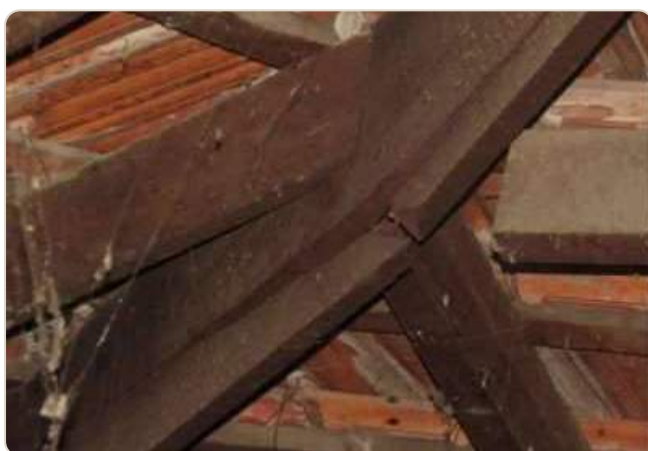
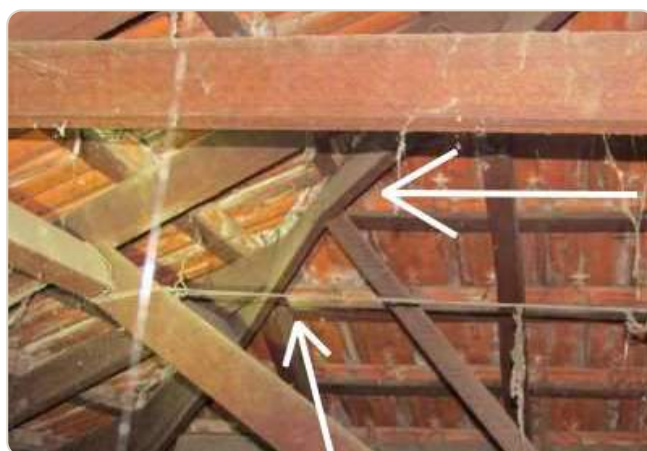
**ROOF FRAME — STRUCTURAL**

There are several structural defects found to the roof frame: The jarrah-hardwood timbers may have deflected due to under-design or simply just due to overtime. Close inspection of the roof framing shows that the original roof has deflected(sagged) and split, with more notable deflection of the hip rafters. Both hip beams of the original building, have deteriorated and deflected. There is also a local failure of other roof rafters, at their connection to the hip beam. The roof junction, between the original building and kitchen extension, is shown below. Note the warping of the eaves support beam shown by the arrow, indicating possible roof movement from the original building roof structure, placing an outward force, in a similar manner to that described above. No recent roof strengthening measures were noted during the site inspection.

The roof frame has significant structural defects, including sagging, splitting, and deflection of hip rafters and beams. This indicates serious underlying issues that compromise the structural integrity of the roof and could lead to further collapse or damage if not repaired.

Engage a licensed and indemnified roofing company or structural engineer to design and construct roof strengthening measures.

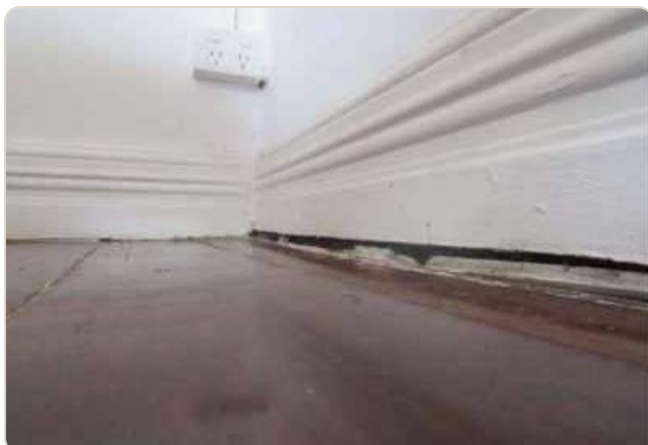
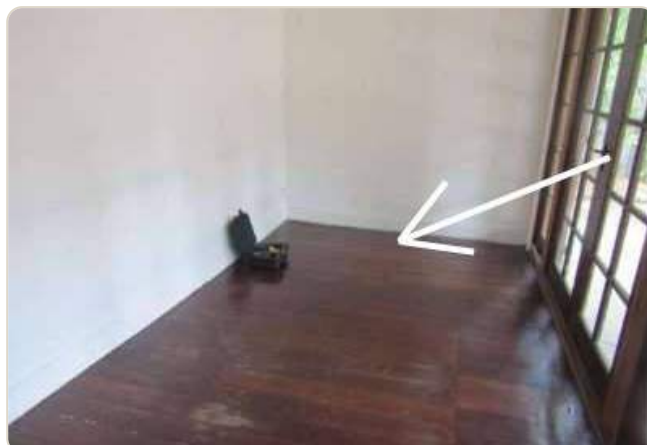
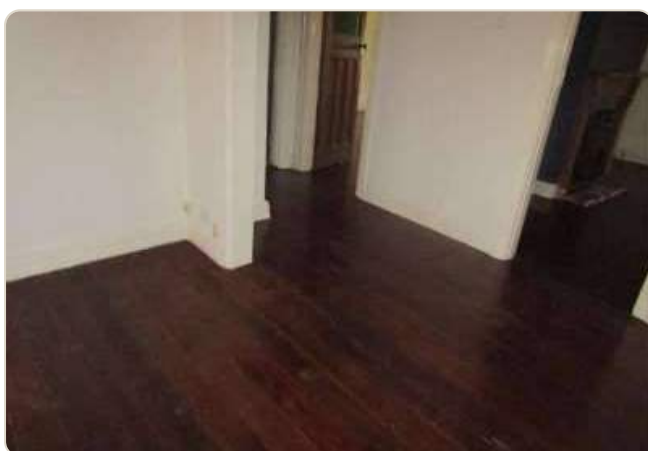
**SUBFLOOR — STRUCTURAL**

Currently the majority of timber stumps were found to be displaying heavy to moderate staining at the base of the timber stumps indicating moisture absorption with deterioration noted as setting into the base of these timber stumps. A number of timber stumps were found to have already failed. The timber stumps that have failed are deemed to be structurally defective potentially adversely affecting the structural integrity of the house. Two floor joists supporting the front wall of the house located directly underneath the front wall of the front sun room / ex front veranda, are displaying moderate to heavy deterioration / rot with fungal growth on these floor joists indicating heavy moisture absorption. These two floor joists are deemed to be structurally defective potentially adversely affecting the structural integrity of the house. It is recommended that these two floor joists are replaced sooner rather than later.

Many timber stumps supporting the house show signs of moisture damage and deterioration, with some having already failed, compromising the home's structural integrity. Additionally, two floor joists under the front wall are rotting with fungal growth due to moisture. These issues need immediate attention to prevent further structural damage.

Engage a licensed builder or restumping specialist to replace failed timber stumps with concrete stumps and replace the deteriorated floor joists.

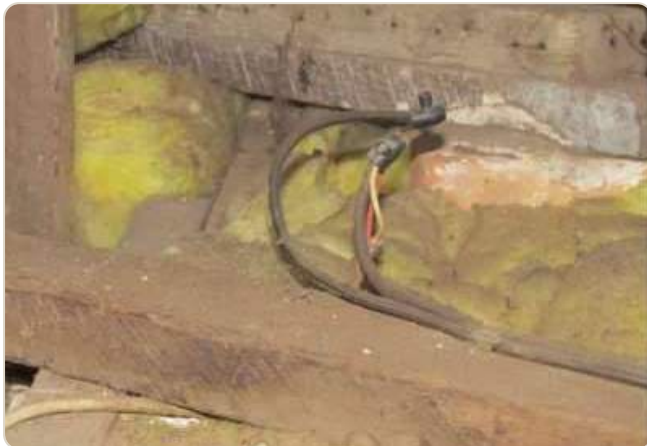
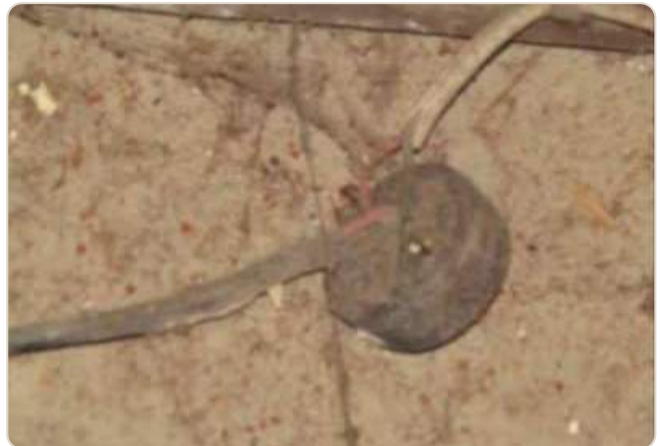
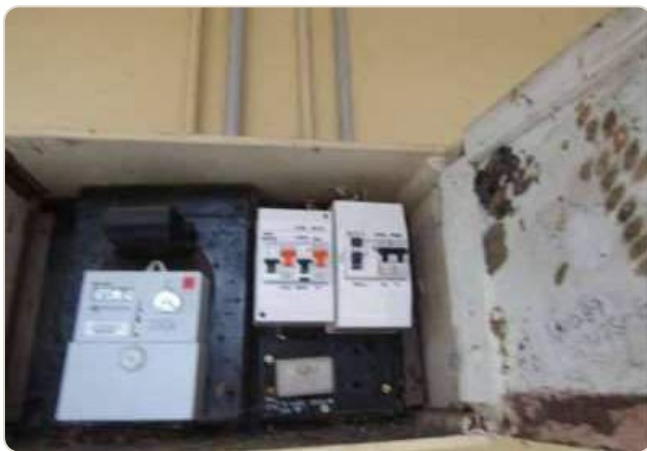
**ELECTRICAL WIRING (ROOF VOID) — ELECTRICAL**

There is still old (live) electrical wiring in this house. Make sure to shut down the electrical power before you or somebody else is entering the roof void for inspections or maintenance. Uninsulated wiring can cause electrocution and I would strongly recommend engaging an electrician to upgrade the wiring to nowadays standards.

The house contains old, uninsulated electrical wiring, especially in the roof void, which is a significant safety hazard. This outdated wiring poses a risk of electrocution and should be upgraded to modern standards to ensure safety.

Engage a licensed electrician to inspect and upgrade the electrical wiring to current safety standards.

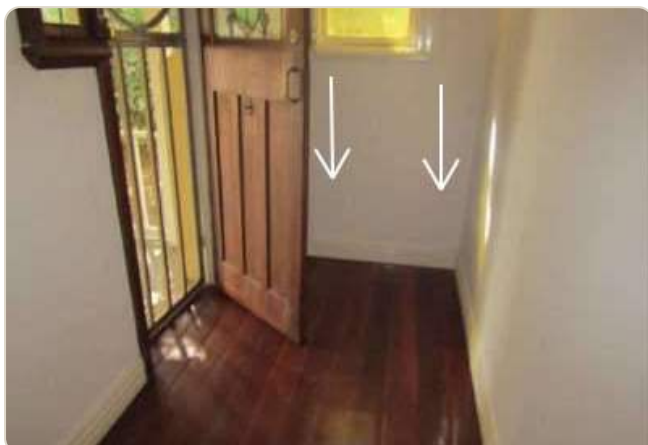
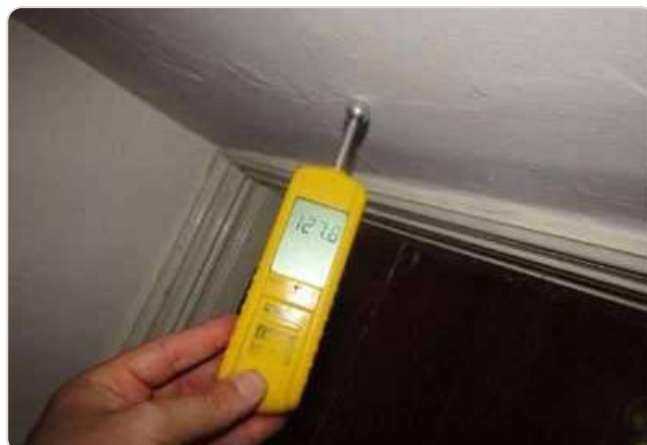
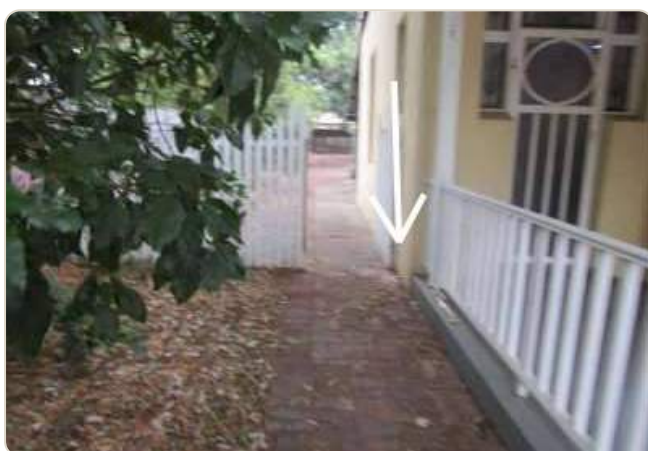
**FRONT AREA EXTERNAL WALL — DAMP**

Evidence of rising damp was found to the front area. It is believed that the waterproofing membrane on the external wall of this house has failed or that the cavity is bridged by mortar or debris allowing external moisture to damage internal plaster. Moisture level: 121 digits indicating wet conditions. The solution to rising damp is usually to remove damaged plaster, inject a chemical damp proof course to both internal and external walls in order to protect against external moisture and to replaster walls with a water proof layer up to the required height.

There is significant rising damp in the front area, likely due to a failed external wall waterproofing membrane or debris bridging the wall cavity. This issue is causing internal moisture damage and will continue to worsen if not professionally treated.

Engage a qualified waterproofing company to investigate the rising damp and install a damp proof course along the affected wall.

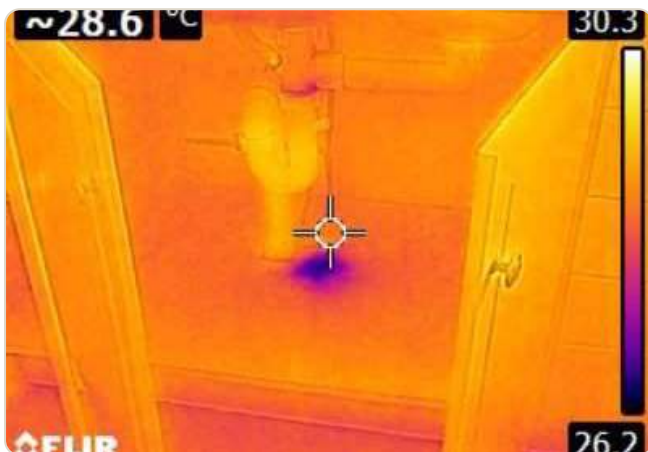
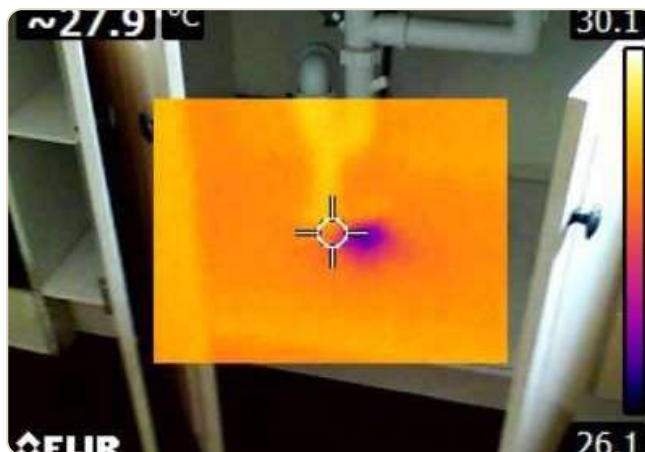
**KITCHEN SINK — PLUMBING**

A minor leakage was evident below the kitchen sink. Inspection of the plumbing system did not reveal the need for improvement, however, this is not an opinion of a licensed plumber.

There is a minor leak visible under the kitchen sink. While not currently severe, any leak can lead to water damage or mould if left unaddressed.

Engage a licensed plumber to repair the minor leak under the kitchen sink.

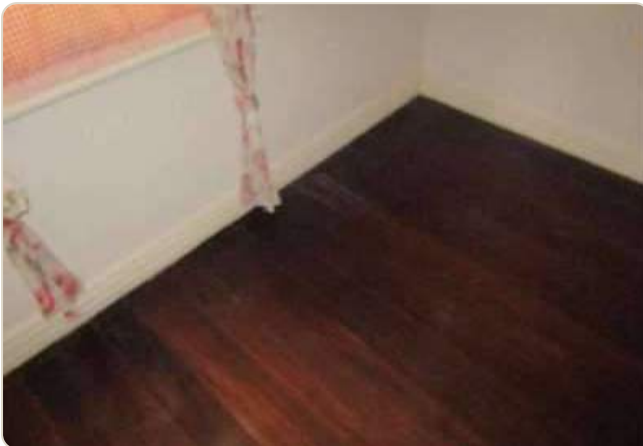
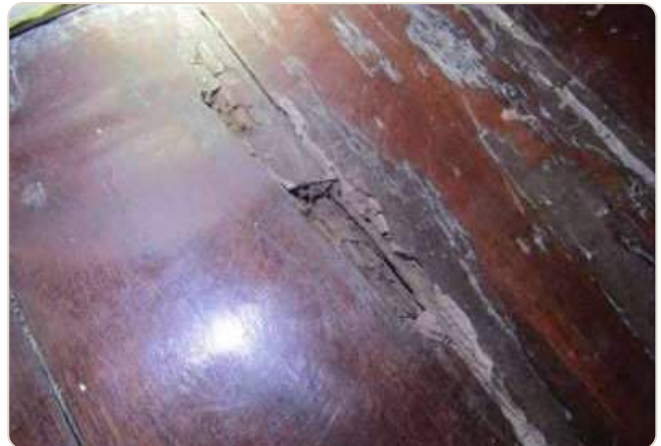
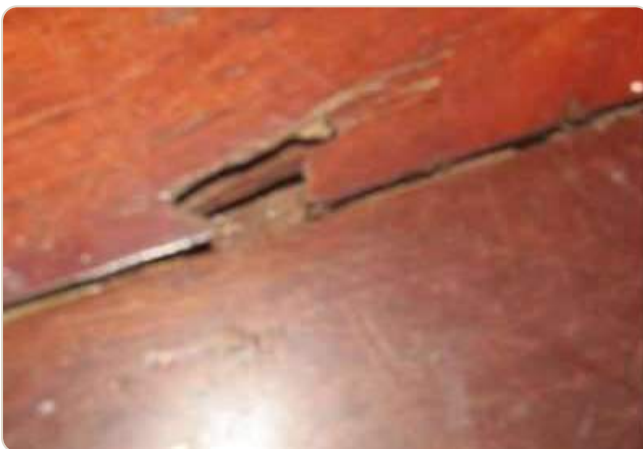
**INTERNAL TIMBER FLOORBOARDS — PEST**

It should be noted that some old termite damage could be found to the timber floorboards in several areas. Under test conditions, it was revealed that the termite workings were inactive (i.e. the absence of live termites at the time of inspection).

Old termite damage was found in several timber floorboards, but no live termites were detected at the time of inspection. While currently inactive, this indicates a historical pest issue that may recur.

Engage a pest control technician for regular inspections and consider timber repair for damaged floorboards.

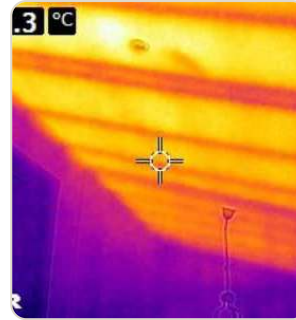
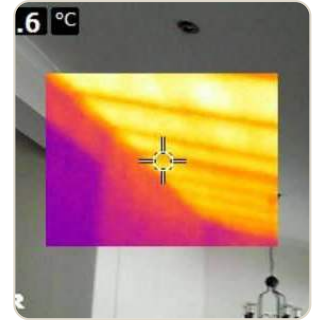
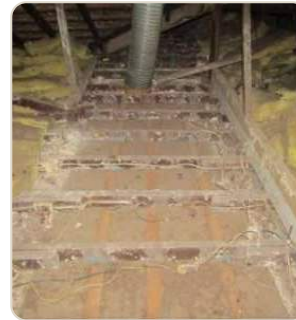
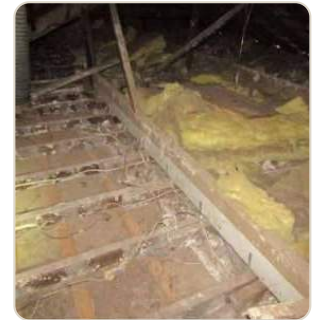
## ROOF SPACE

Insulation is missing in some parts of roof space. This would reduce the overall performance of the insulation. Recommend to install insulation were missing. Upgrading insulation levels in a home is considered to be an improvement, rather than a necessary repair.

**WHAT THIS MEANS FOR YOU · BuyersReport**  
Some areas of the roof space are missing insulation, which reduces the home's energy efficiency. While not a defect, installing insulation in these areas is a recommended improvement for comfort and energy savings.

**OUR RECOMMENDATION · BuyersReport**  
Install insulation in the areas of the roof space where it is missing.

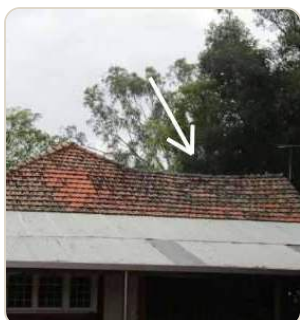
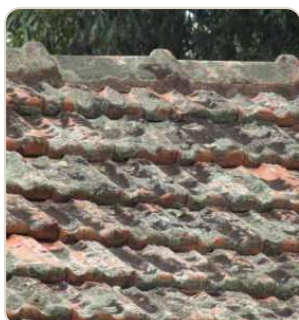
**ROOF COVERING**

The original roof covering is considered to be in acceptable condition considering the age. Some general roof frame undulations and displacement to some tiles to settlement in overtime were noted. The displacement of the clay tiles, from the roof deflection, may also allow driving-rain to penetrate through the tiles. A roof tiler is required for general repairs. Moss is growing on the roof. As a result, the clay tiles may lift or be damaged. Leaks may result and/or the roof surface may fail prematurely. Efforts should be taken to kill the moss during its growing season (wet months).

The clay tile roof has some displaced tiles due to historical settlement and undulations in the roof frame, which could allow water to enter during heavy rain. Moss growth is also present, which can damage tiles and lead to premature roof failure.

Engage a roof tiler for general repairs, including reseating displaced tiles, and treat the moss growth.
